# Transmission Stability and Infrared Windows:

## The Effects of Transmissivity on Data Accuracy

*by: Joe DeMonte*
*ASNT/PdM Level III Thermographer*

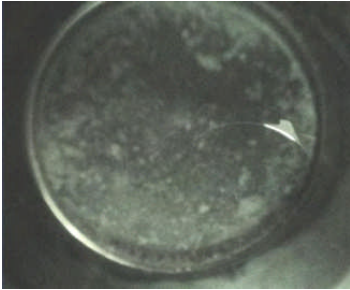
*Figure 1 – Calcium Fluoride Sightglass*

e across a Calcium Fluoride infrared sightglass (shown in Figure 1) which had lost all transmissivity in the infrared and visual spectrums. It was being used in a motor termination box in an electrical generation plant in Tennessee. This is an extreme case to be sure, but it is not without precedence.

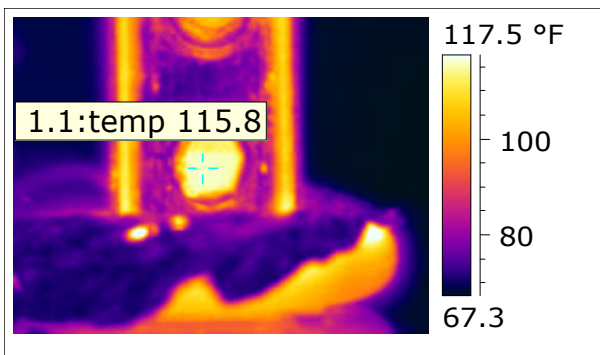
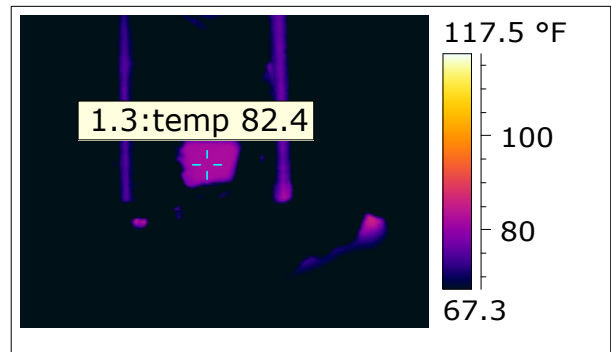
*Thermogram 1.1*

Thermogram 1.1 shows the thermal image of the overhead line clamp with no infrared window. The target temperature is shown to be 115.8°F (45.6°C). We will call this the true temperature.

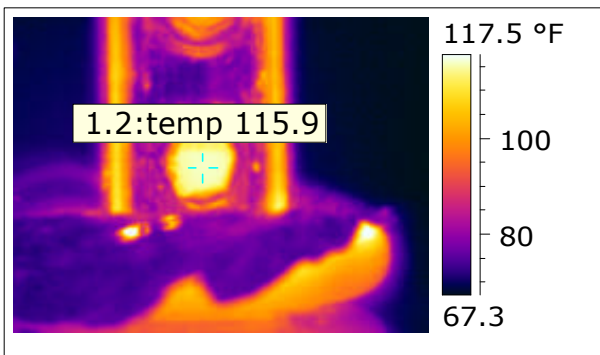
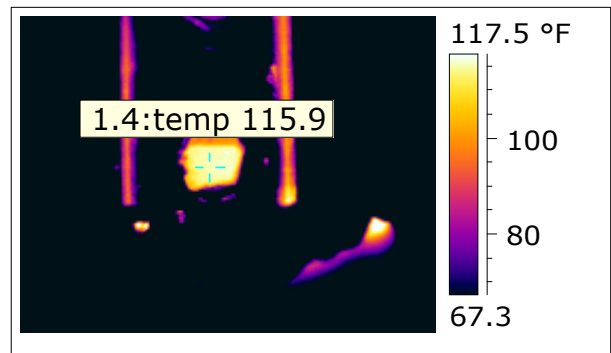
*Thermogram 1.2*

Thermogram 1.2 shows the same target through the Polymer Control Window, with the τ set to 0.49 per the baseline established when it was new. The target temperature is shown to be 115.9°F (45.6°C): a statistically insignificant 0.09% error between apparent and true temperatures, which is well within the +/-2% accuracy ratings for the camera used in the tests.

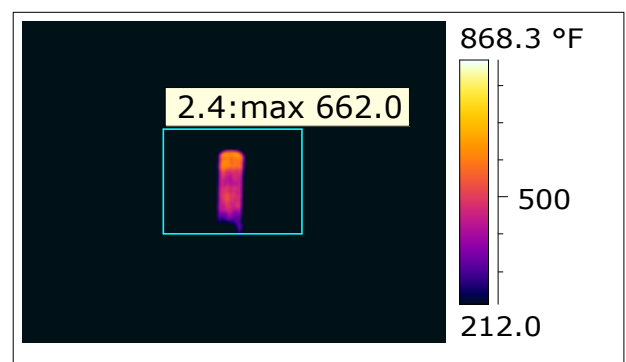
*Thermogram 2.3*

Thermogram 2.3 shows the same target through the CaF$_2$ Test Window, with the $\tau$ set to 0.49 per the baseline established when it was new. However, in this case the apparent temperature registers as 485.7°F (252.1°C), resulting in a 175.6°F (97.5°C) or 26.55% error between apparent and true temperatures.
