Technical Data

SonaVu™ Ultrasonic Acoustic Imaging Camera for Compressed Air Leak Management

SonaVu™ Ultrasonic Acoustic Imaging Camera

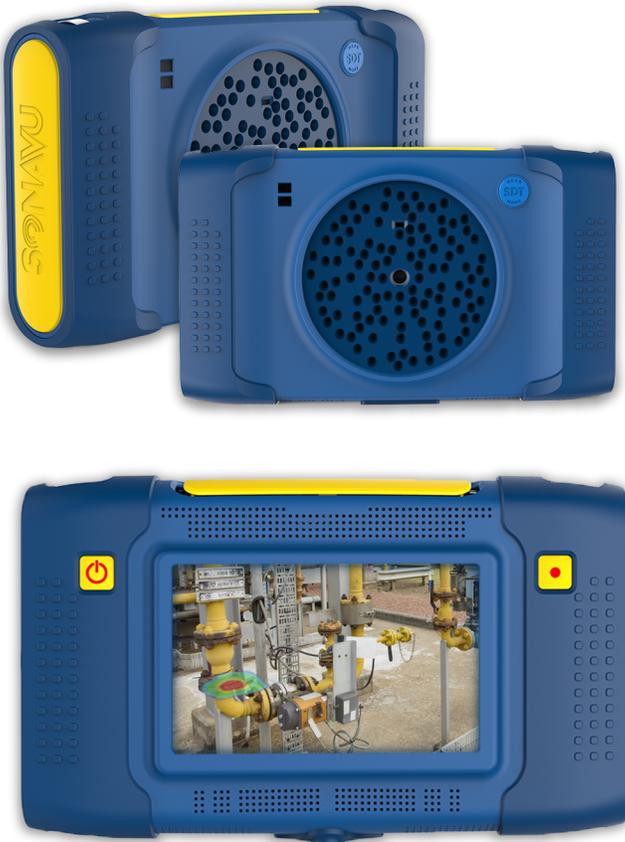
SonaVu™ (powered by SDT) is a multi-frequency acoustic imaging camera that blends visual and auditory senses to bring compressed air leaks into focus.

SonaVu™ is a multi-frequency acoustic camera that takes airborne ultrasound inspection to a new level. Equipped with 112 highly sensitive sonic sensors and a precision optical camera, SonaVu™ brings the power of super-human hearing to focus on its vibrant, color touch screen. It unlocks limitless applications for asset reliability, energy conservation, and safety including compressed air leak management, electrical asset reliability, tightness control of large volumes, and much more.

A simple leak detection procedure consists of picking up the SonaVu™ and powering it on. Connect the high-quality noise attenuating headphones so you can hear what SonaVu™ hears. Then simply point the acoustic sensor array towards any compressed air lines. Listen for the characteristic hissing of the air leaks in the headphones and watch the color display light up with the precise location of the leak.

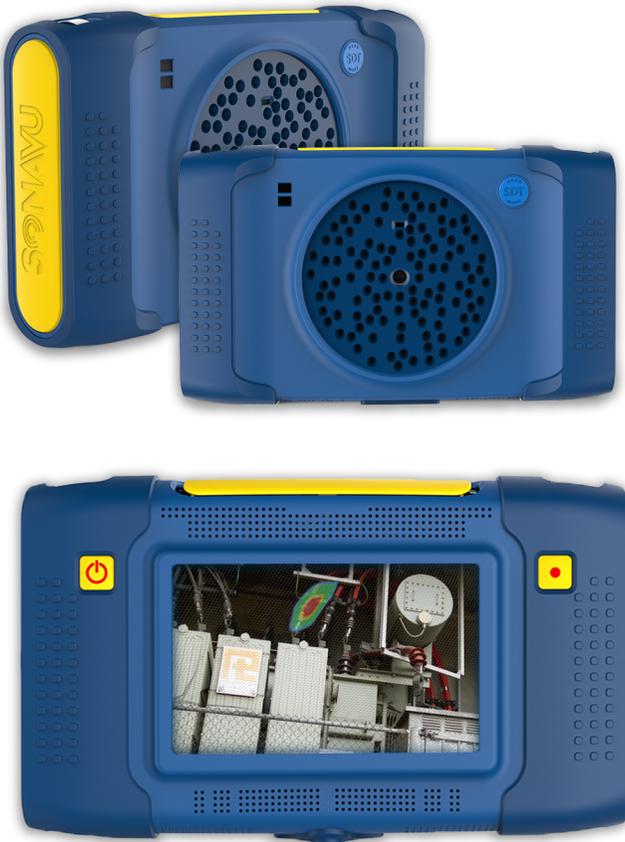
The procedure for scanning is straightforward. Connect the noise attenuating headphones to the SonaVu™ and position the sensors towards potential sources. The ultrasound produced by partial discharge excites the sensors while their location is revealed on the display. Tap the icon to capture either a video or still image to place it into your inspection report. It's that easy!

Sources of ultrasound created by the presence of partial discharge are superimposed on the image allowing inspectors to intuitively pinpoint their location.

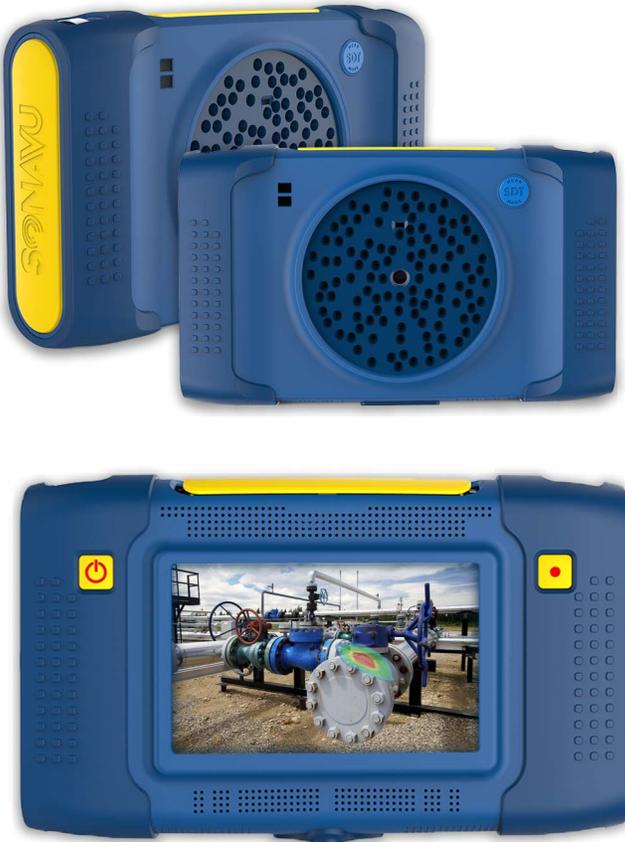
SonaVu™ is a multi-frequency acoustic imaging camera that blends visual and auditory senses to bring fugitive emissions, natural gas, and oil leaks into focus.

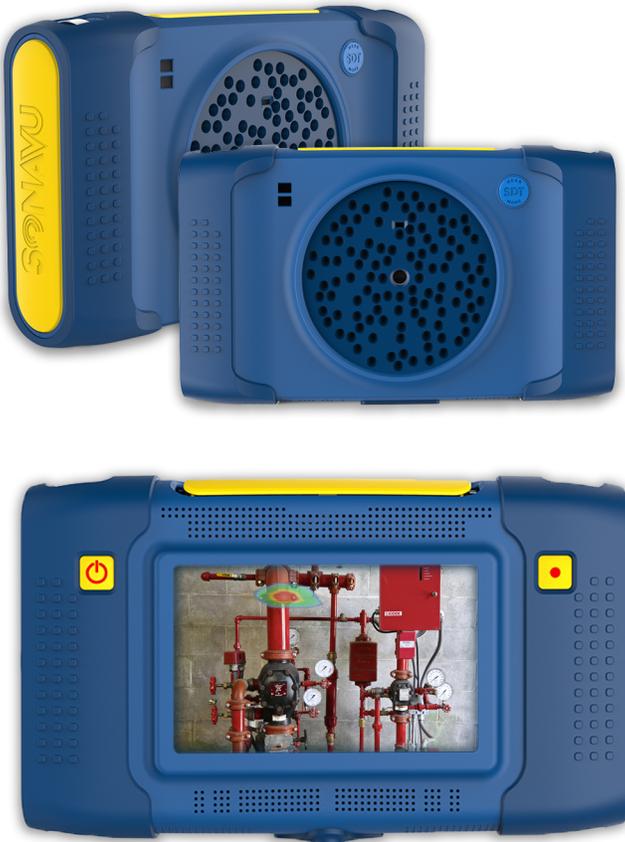
SonaVu™ (powered by SDT) is a multi-frequency acoustic imaging camera that blends visual and auditory senses to faults that threaten the reliability and safety of dry pipe sprinkler systems. Its 112 highly sensitive sonic sensors work in concert with a precision optical camera. SonaVu™ brings the power of superhuman hearing to focus on its vibrant color screen.

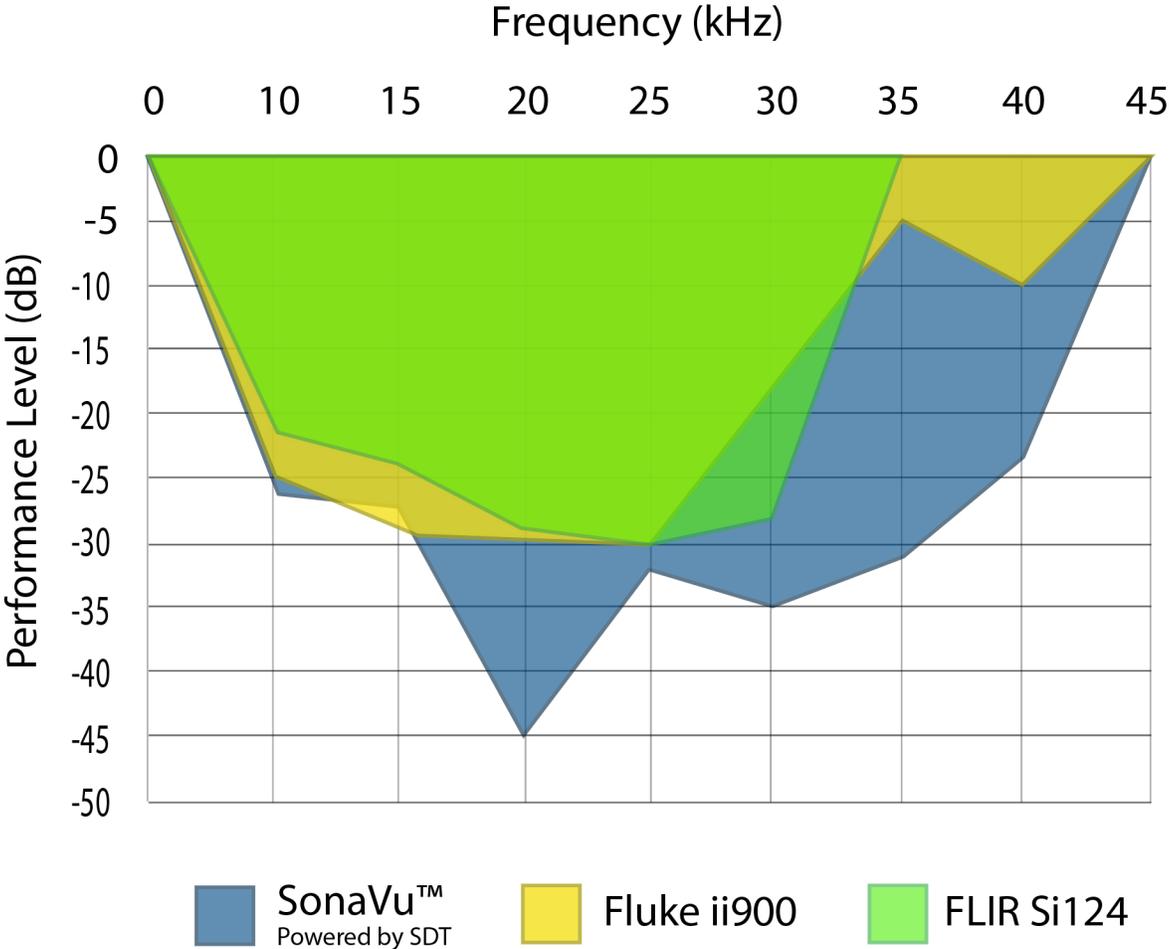
Performance Level Comparison
SonaVu™ Ultrasonic Acoustic Imaging Camera

Minimum detectable sound pressure level and measurement range
